Combustion Device Failures During Space Shuttle Main Engine Development

Otto K. Goetz
NASA

**5th International Symposium on Liquid Space Propulsion
Long Life Combustion Devices Technology**

Chattanooga, Tennessee
October 27-30, 2003

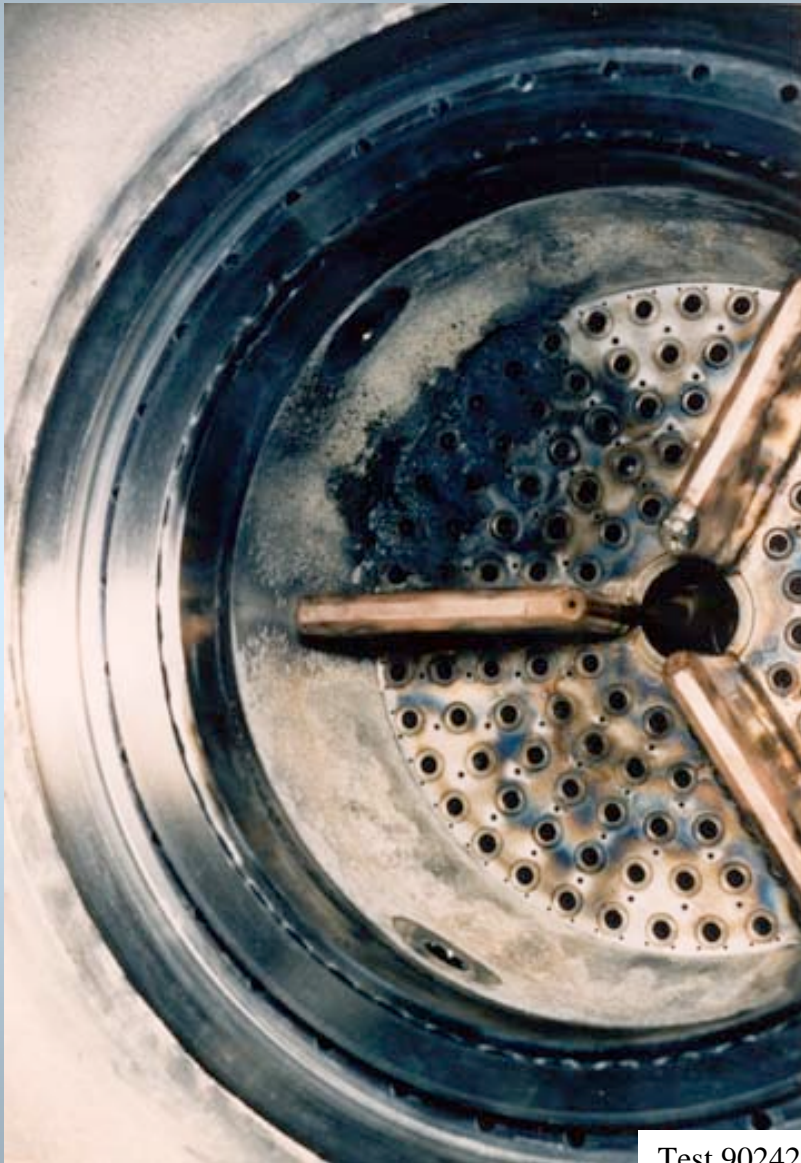
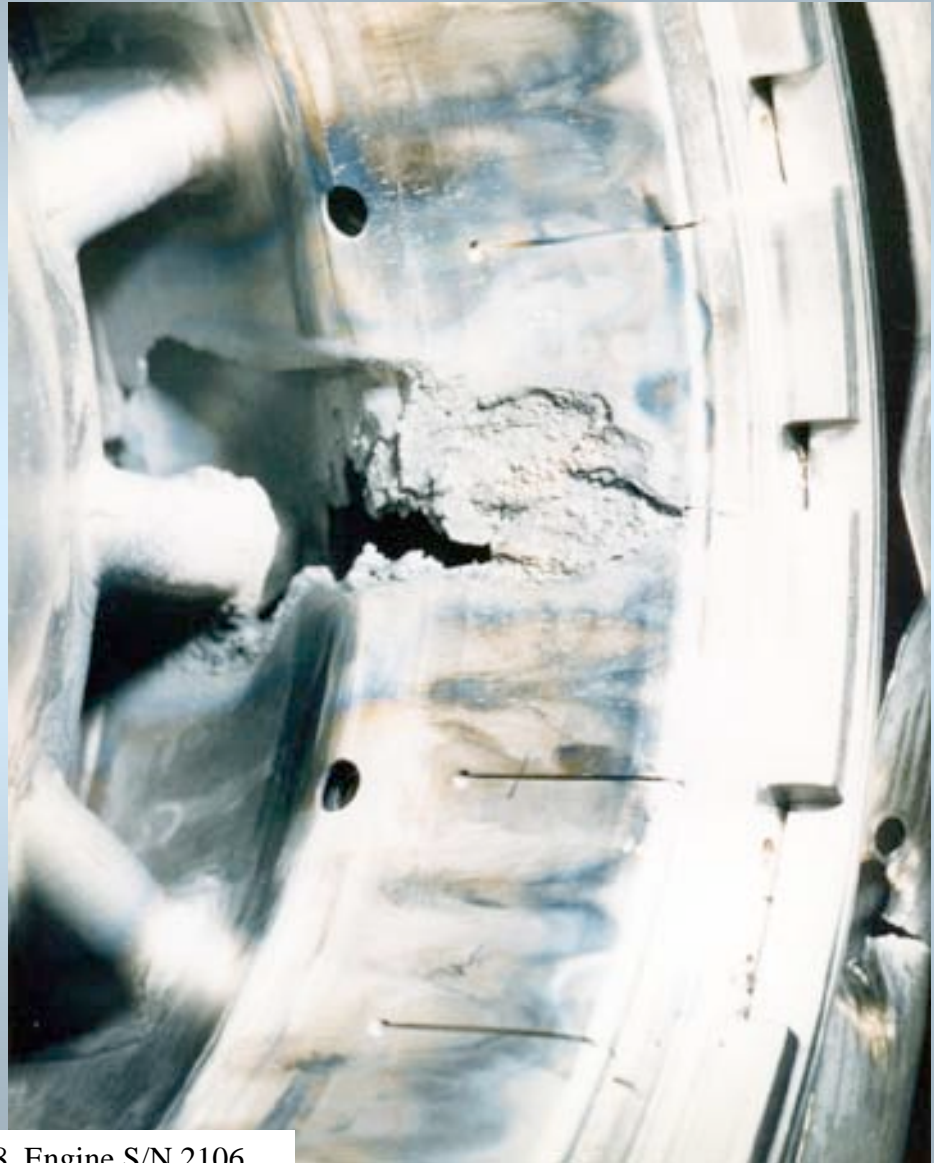
Test 902428, Engine S/N 2106

Post test inspections revealed moderate erosion in one quadrant on the OPB faceplate and a hole through the HPOTP turbine inlet sheet metal. Leakage tests of the OPB interpropellant plate conducted on the engine revealed leak at baffle number 2, row A pin (2A).

Cause: Poor quality braze joints (greater than 90 percent porosity) at row A baffle pin to interpropellant plate joint. The large porosity was related to poor process control techniques used in the laboratory furnace. The poor quality braze joint failure was most probably due to low cycle fatigue.

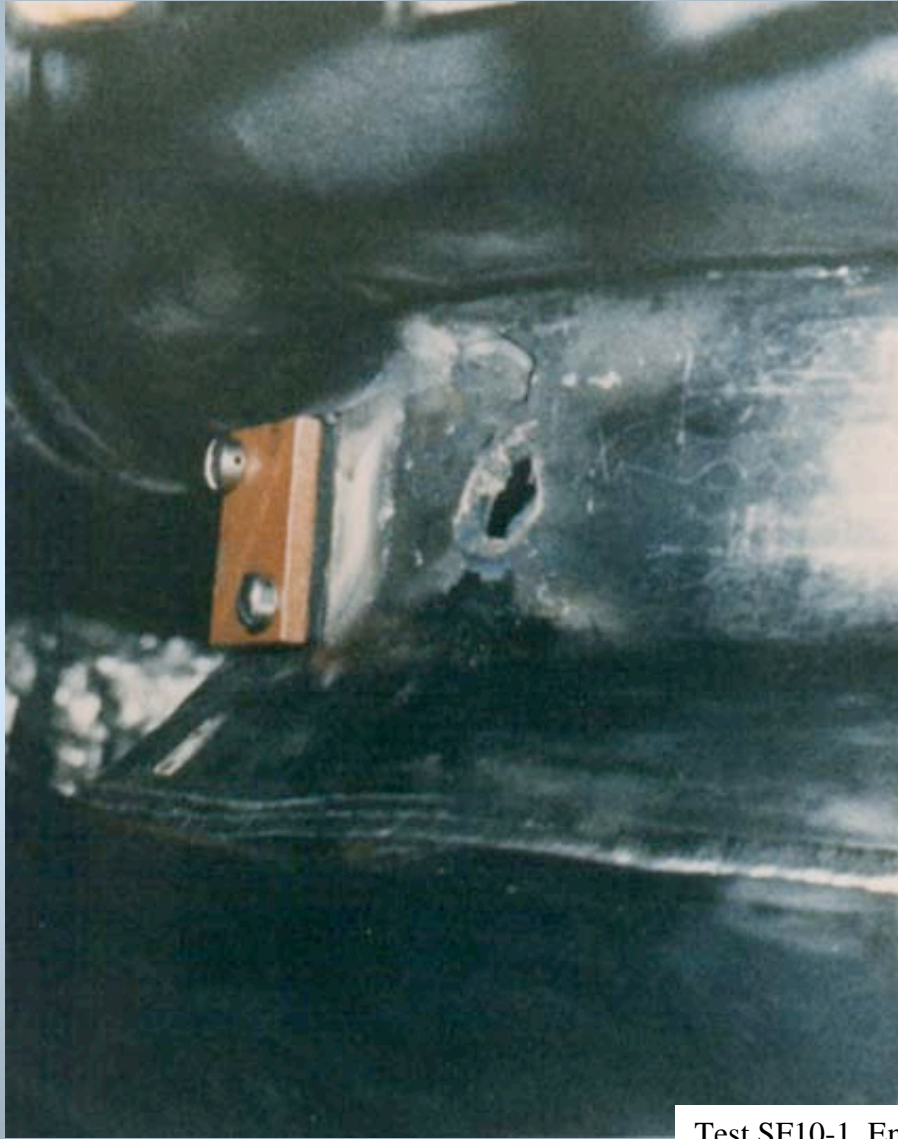
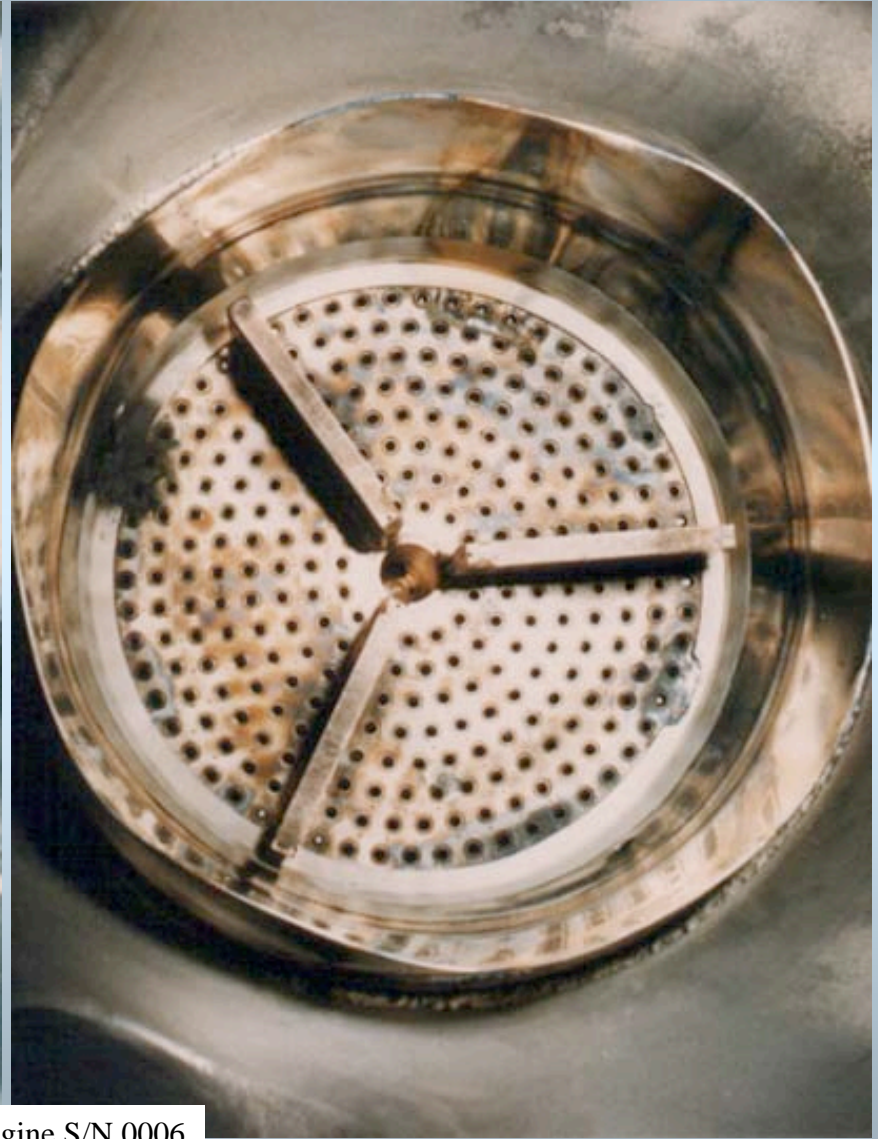
Test SF10-1, Engine S/N 0006

Incident Description: Test SF10-1 was prematurely terminated at 106.6 seconds when fire detectors and hazardous gas detectors triggered in the aft fuselage, and the fire detect redline observer terminated the test.

Cause: Individual element Lox posts were not concentric with the fuel annuli, causing a fuel restriction on the outboard side of the outer row elements.

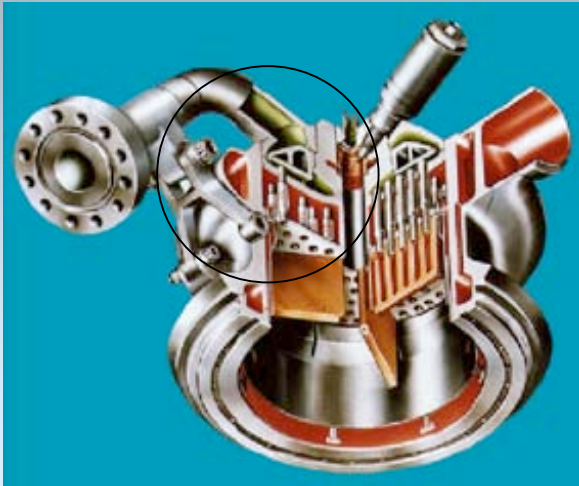
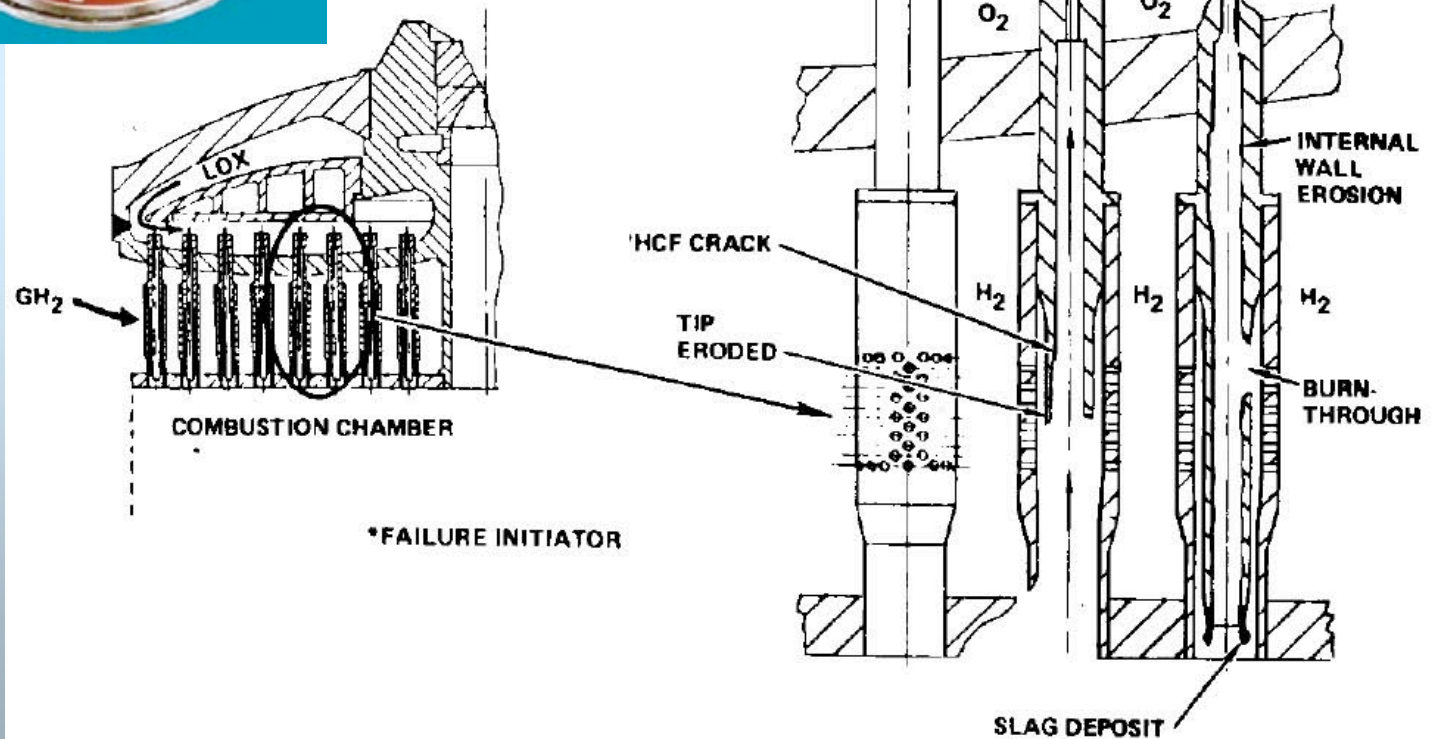
Test 901307, Engine S/N 0009

Incident Description: Test 901307 proceeded through programmed shutdown. A metallurgical examination revealed a crack in one Lox post in the fuel preburner. Fuel mixes with Lox through the crack, ignites, and burns the Lox post tip. GH2 backflows into the Lox dome through the damaged element after shutdown has been initiated. The recirculating GH2 ignites with residual Lox and causes additional injector damage.

Cause: High Alternating stresses resulting from combined mainstage mechanical vibration and flow induced vibration associated with element hydrogen flow.

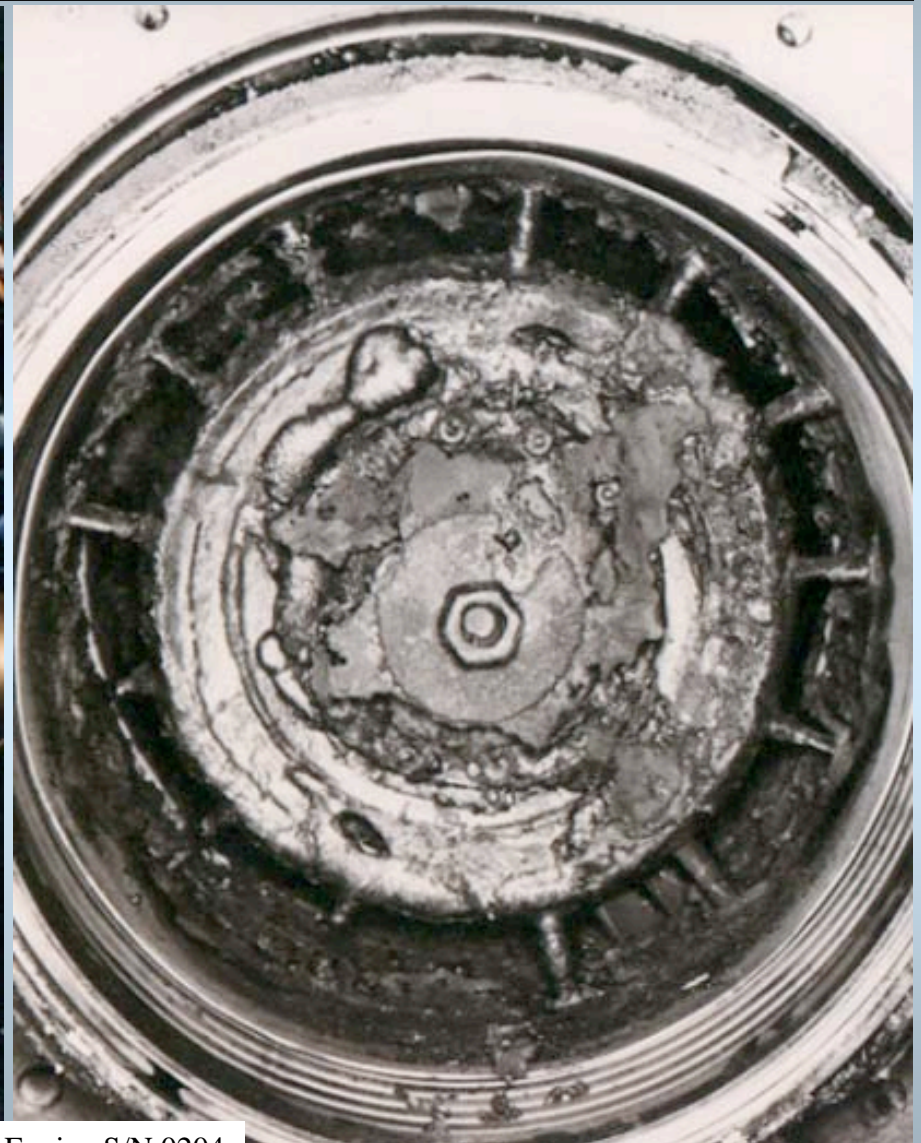
Test 902249, Engine S/N 0204

Incident Description: Test 902249 was terminated at 450.58 seconds when the HPFTP accelerometer measurements exceeded the redline value. Posttest inspection of the engine revealed a section of the HPFTP inlet volute missing, severe damage to the Main Combustion Chamber (MCC) and Main Injector, the nozzle, HPFTP and HPOTP turbine sections, the heat exchanger and the Hot Gas Manifold. The missing section of the HPFTP inlet volute caused the loss of all of the fuel from the engine leading to a highly oxygen rich shutdown.

Cause: FPB injector face had experienced damage during a prior test and had been repaired by plugging several oxidizer posts in one quadrant resulting in a circumferential temperature gradient in the preburner. Localized high temperature streaking caused disbonding of the first stage turbine tip seals; excessive rubbing of the blades caused blade failure, sudden rotor speed decay and resulting HPFTP inlet volute rupture and Lox rich shutdown.

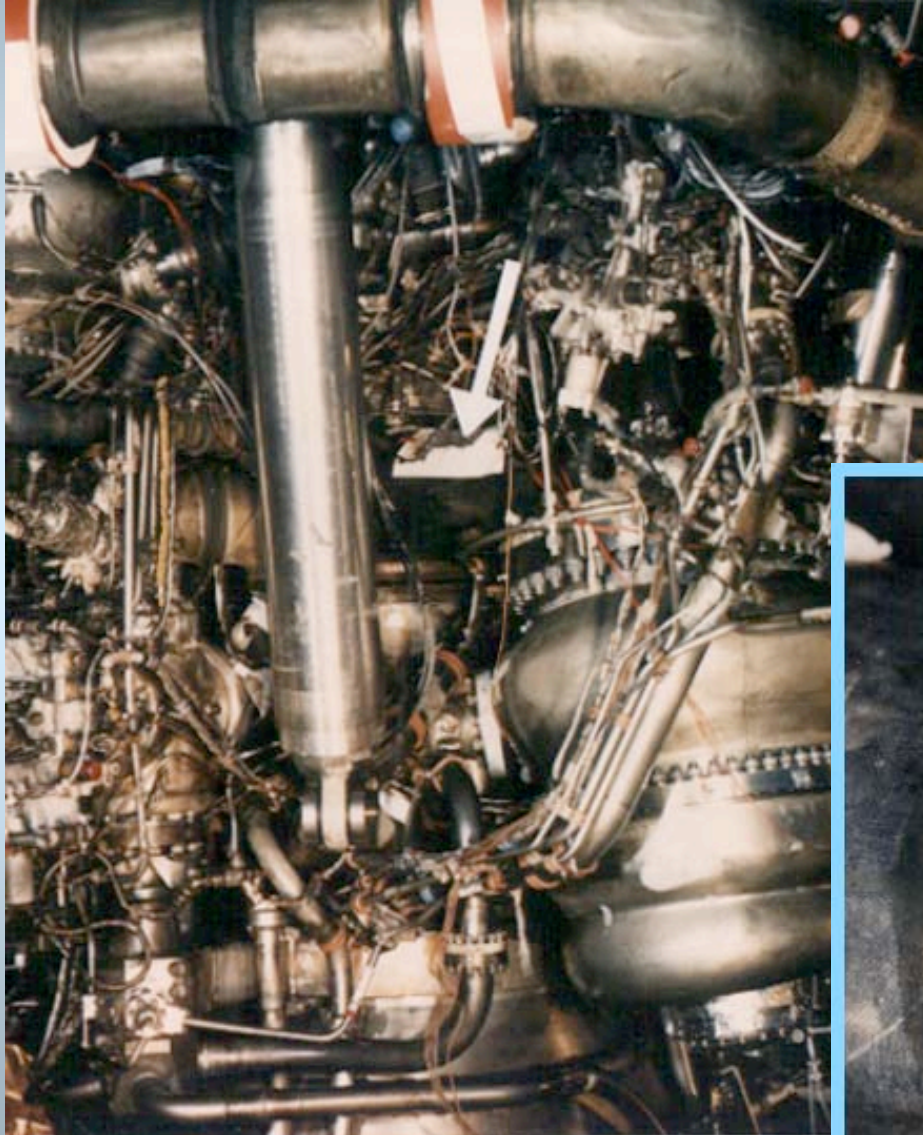
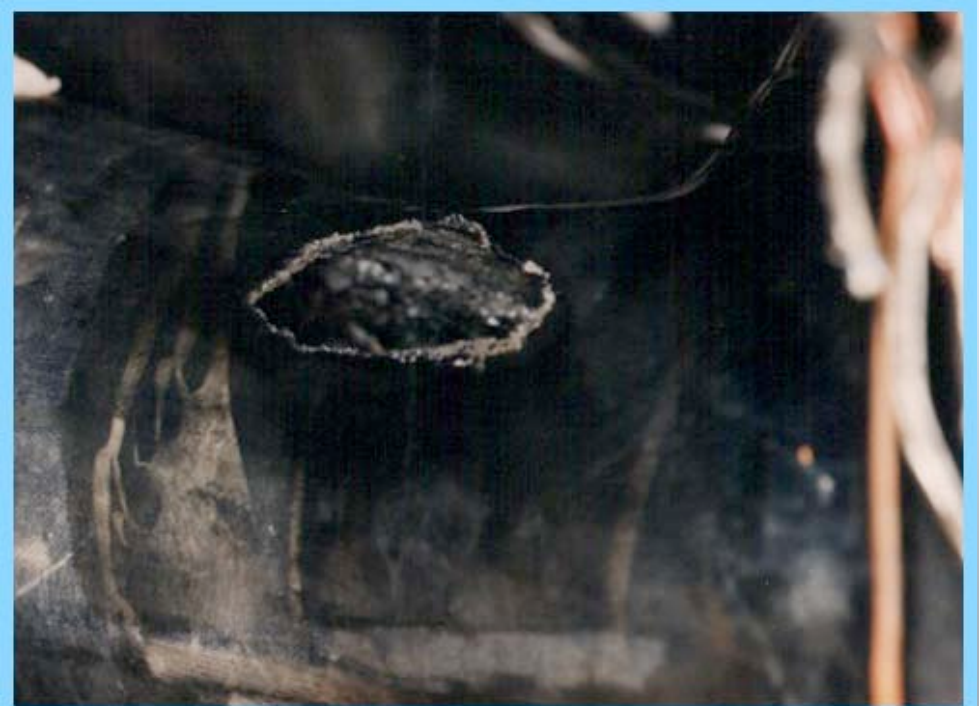
Test 750160, Engine S/N 0110F

Incident Description: Test 750160 was prematurely terminated at 3.16 seconds by the HPFTP Turbine discharge temperature redline. Posttest hardware inspection revealed severe erosion damage to the high pressure fuel and oxidizer turbines, main injector, MCC, nozzle, and hot gas manifold. A hole burned through the left side transfer tube resulting in a rupture of the Fuel Preburner Oxidizer Valve actuator hydraulic line and an external fire.

Cause: Data analysis, hardware condition and supporting laboratory tests identified the cause of the incident as EDM water contamination of the fuel system upstream of the fuel preburner. The formation of ice during engine start resulted in fuel flow restriction in some fuel preburner elements. This restriction produced one or more abnormally high temperature combustion gas zones which cause turbine blade erosion and/or failure. The resulting decay in fuel flow to the engine produce excessive combustion gas mixture ratio and subsequent erosion damage.

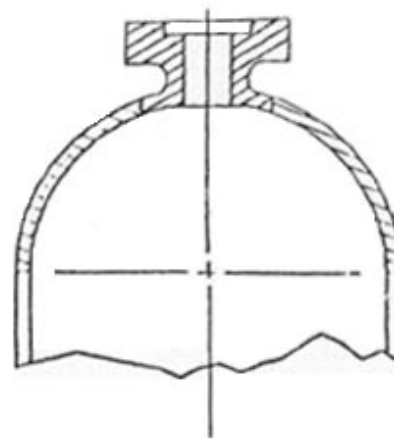
Engine S/N 0207 (One of Nine
Powerheads)

Cause: High cycle fatigue of welded in port. Not flight configuration and only power head in service with welded in instrumentation ports.

Welded Bosses

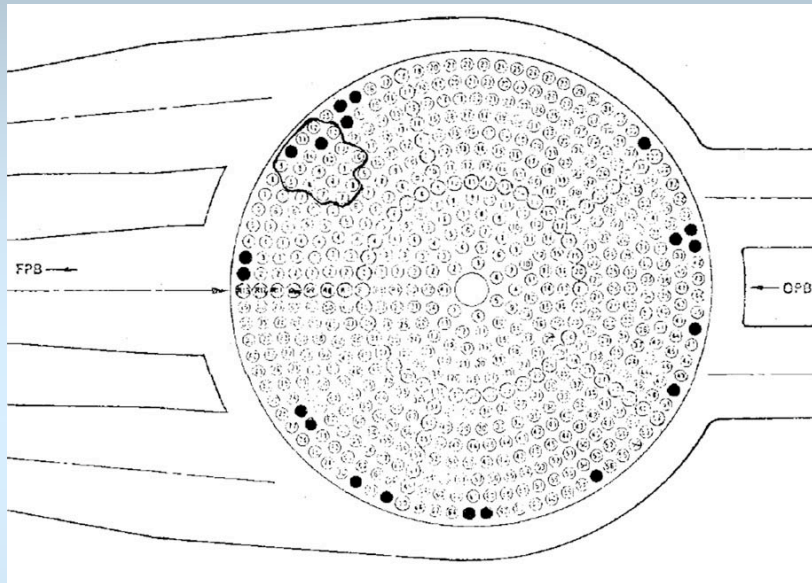
Test 901173, Engine S/N 0002

Incident Description: Test 901173 was terminated at 201.17 seconds when the HPFTP turbine discharge temperature redline was exceeded. At approximately 200.7 seconds, Lox post 10, Row 13 cracked through at the tip radius between the primary and secondary faceplates. Hot gas flow into the lox post ignited and burned out the post. Lox pouring into the face coolant manifold cause burn through of primary and secondary faceplates. Ejection of burned debris caused severe nozzle tube ruptures (46 tubes). Fuel loss couple with engine control reactions to maintain MCC pressure increased the HPFTP turbine temperature to increase until the redline was exceeded.

Cause: High cycle fatigue of the Lox post due to flow and mechanical vibration.

Location of Cracked Posts
and Burnout Area

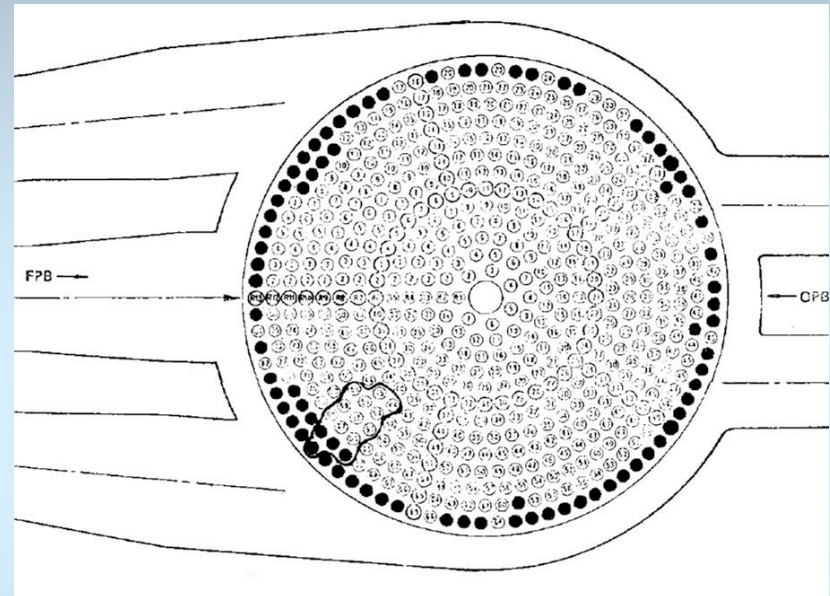
Test 901183, Engine S/N 0005

Incident Description: Test 901183 was terminated at 51.1 seconds by the HPFTP accelerometers because of an unrelated problem. At approximately, 24 seconds, failure of a group of Lox posts began. The condition appears to have limited itself and engine operation stabilized. 15 Lox posts were eroded back to the secondary faceplate and a section of the primary faceplate was burn away. The MCC hot gas wall received minor scalding and the nozzle had a failed saddle patch at one location.

Cause: High cycle fatigue of the Lox post due to flow and mechanical vibration.

Location of Cracked Posts
and Burnout Area

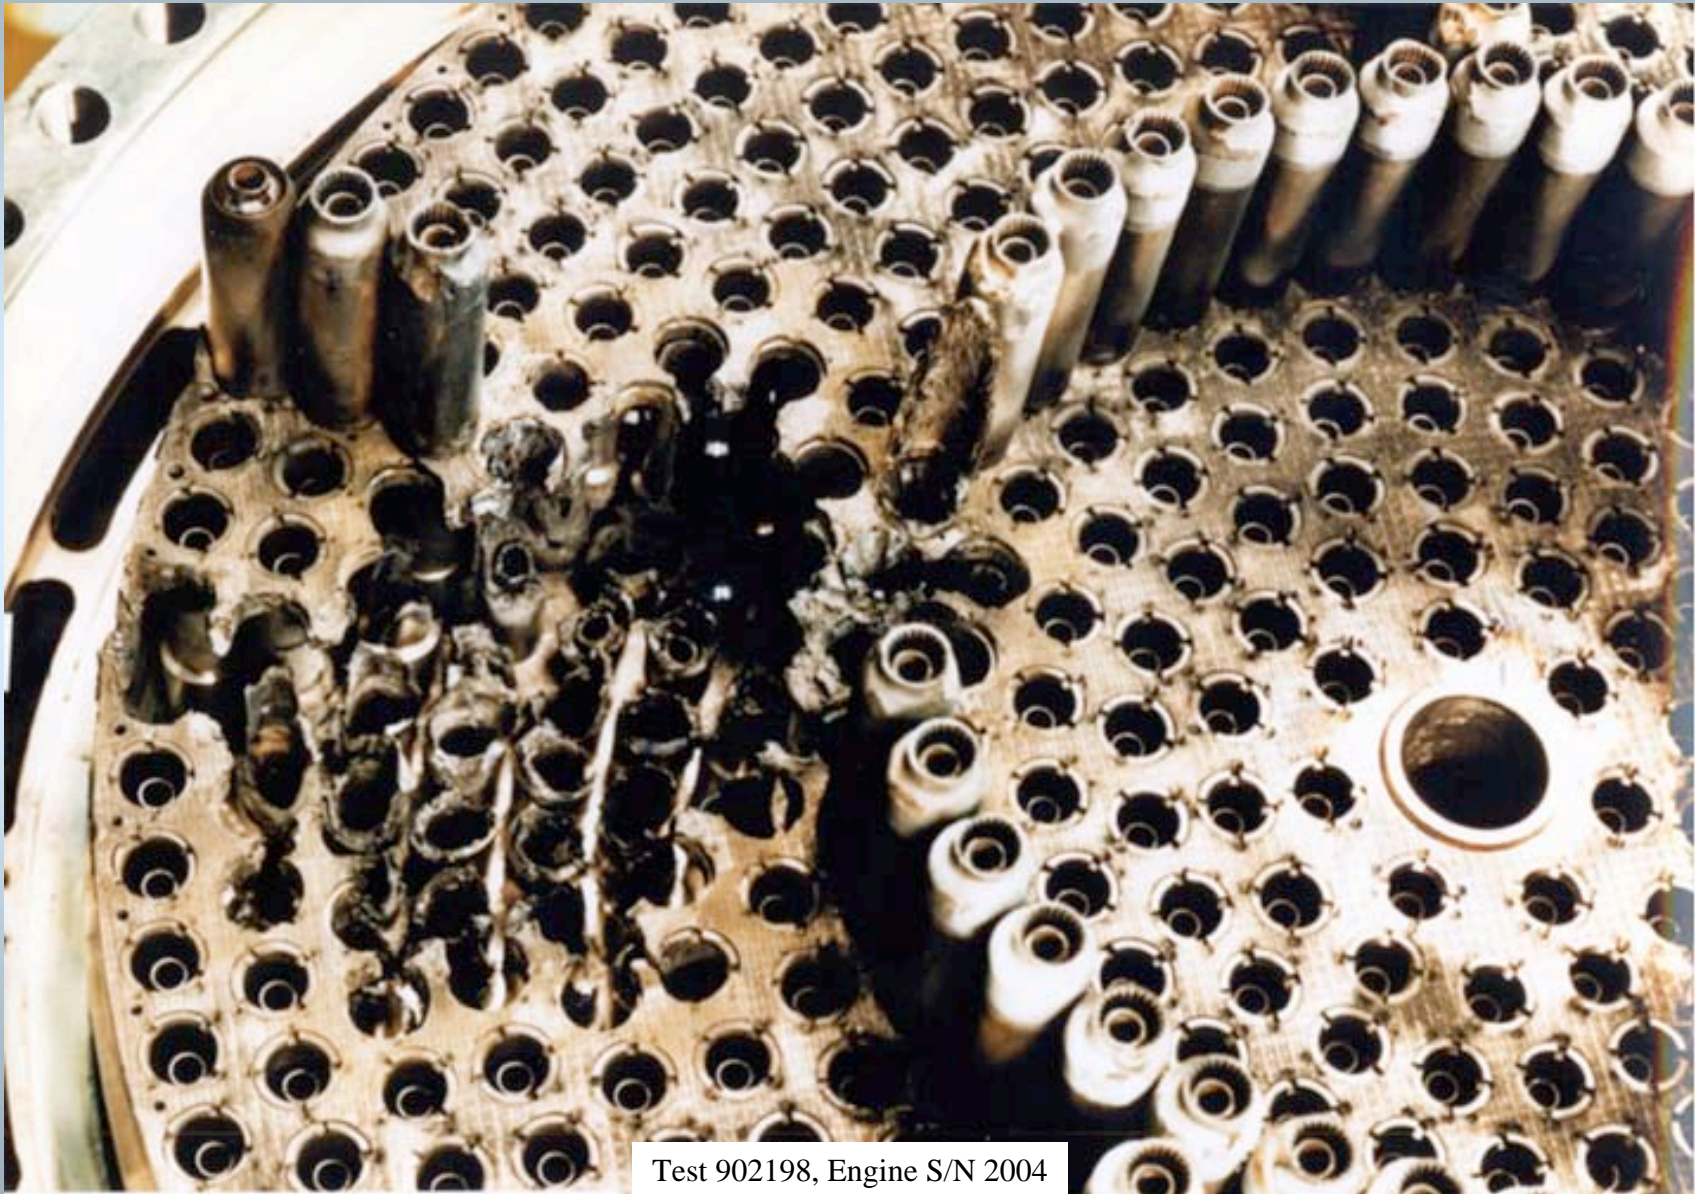
Test 902198, Engine S/N 2004

Posttest hardware inspection and disassembly revealed that the MCC injector was partially damaged, the MCC had slight erosion between two acoustic cavities, and the nozzle had several tubes dented and/or ruptured from the injector debris exiting the engine. No other hardware was damaged.

Cause: The cause of the failure was high cycle fatigue of the Lox post due to flow and mechanical vibration. Metallographical examination of the disassembled injector in rows 13, 12, and 11 revealed that 62 posts were cracked. A cross section of the fillet area of post 61 in row 12 revealed longitudinal wavy lines indicative of the type of cold working accompanying HCF. Visual observation earlier in the disassembly of the injector indicated that post 61, row 12, was the failed post. Post 61 had the most uniform burning with molten metal and slag 360°. The high cycle fatigue of the Lox posts was caused by mechanical vibration of the powerhead and flow induced vibration from the hot gas combined with high steady-state stresses.

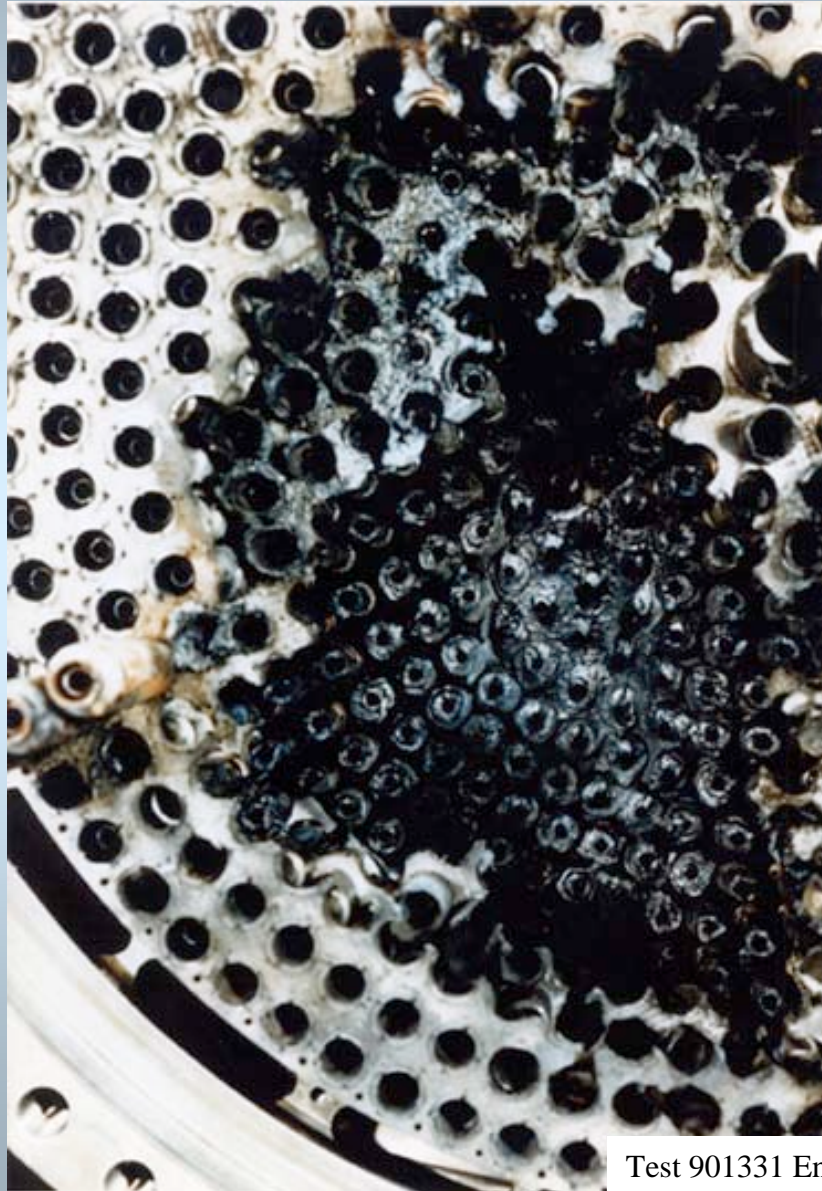
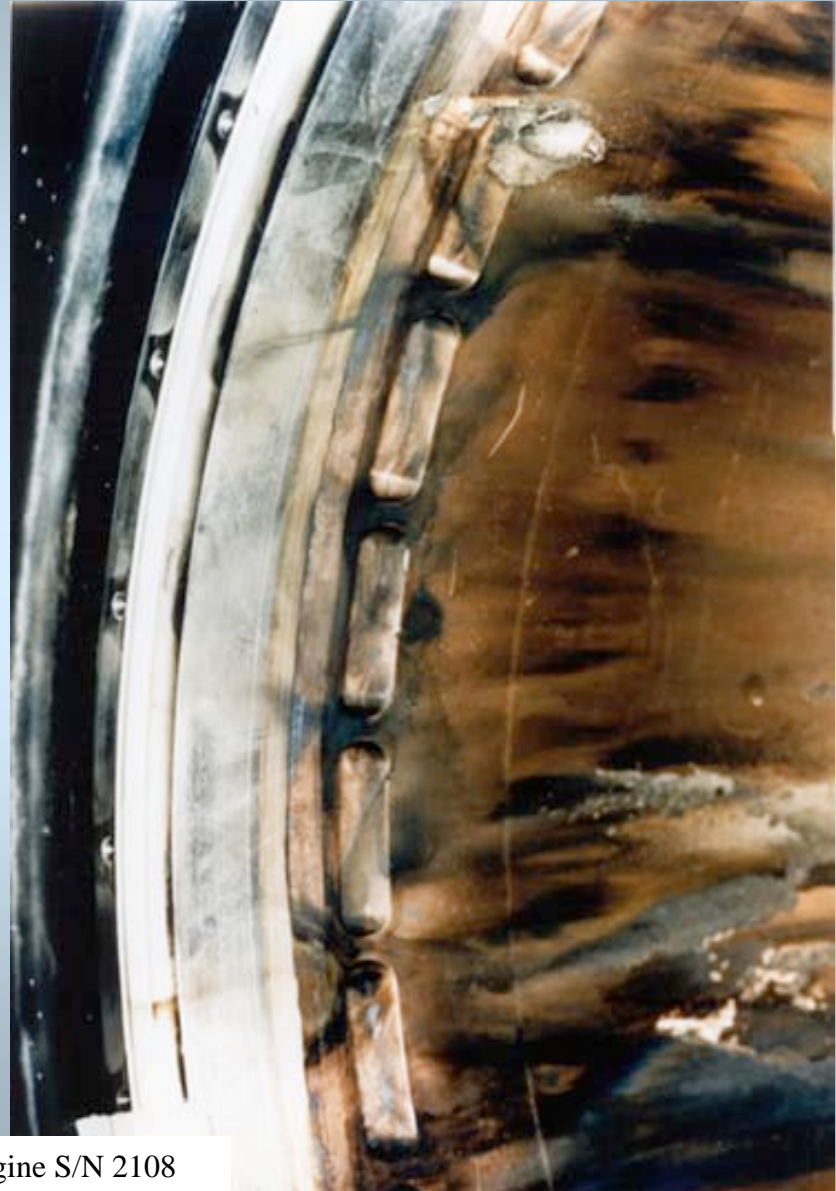
Test 901331 Engine S/N 2108

Inspection of the engine revealed extensive damage on the fuel preburner side of the main injector with burnthrough of 169 Lox posts, major erosion of the primary and secondary faceplates, major erosion of the interpropellant plate, and six Lox post shields damaged. The nozzle sustained shrapnel damage to approximately 60 tubes, and the MCC acoustic cavity suffered erosion damage.

Cause: Lox post number 79 in row 13 failed in the 316L material at the inertial weld (which joins a 316L post to an INC0718 interpropellant plate stub) . The post failure was caused by high cycle fatigue. There was a much larger increase in flow induced vibration in going from RPL to FPL; than had been estimated in life calculations. Furthermore, the modifications which had been made in the high pressure fuel pump to adapt it to FPL operation increased the severity of the flow induced vibrations at all power levels.

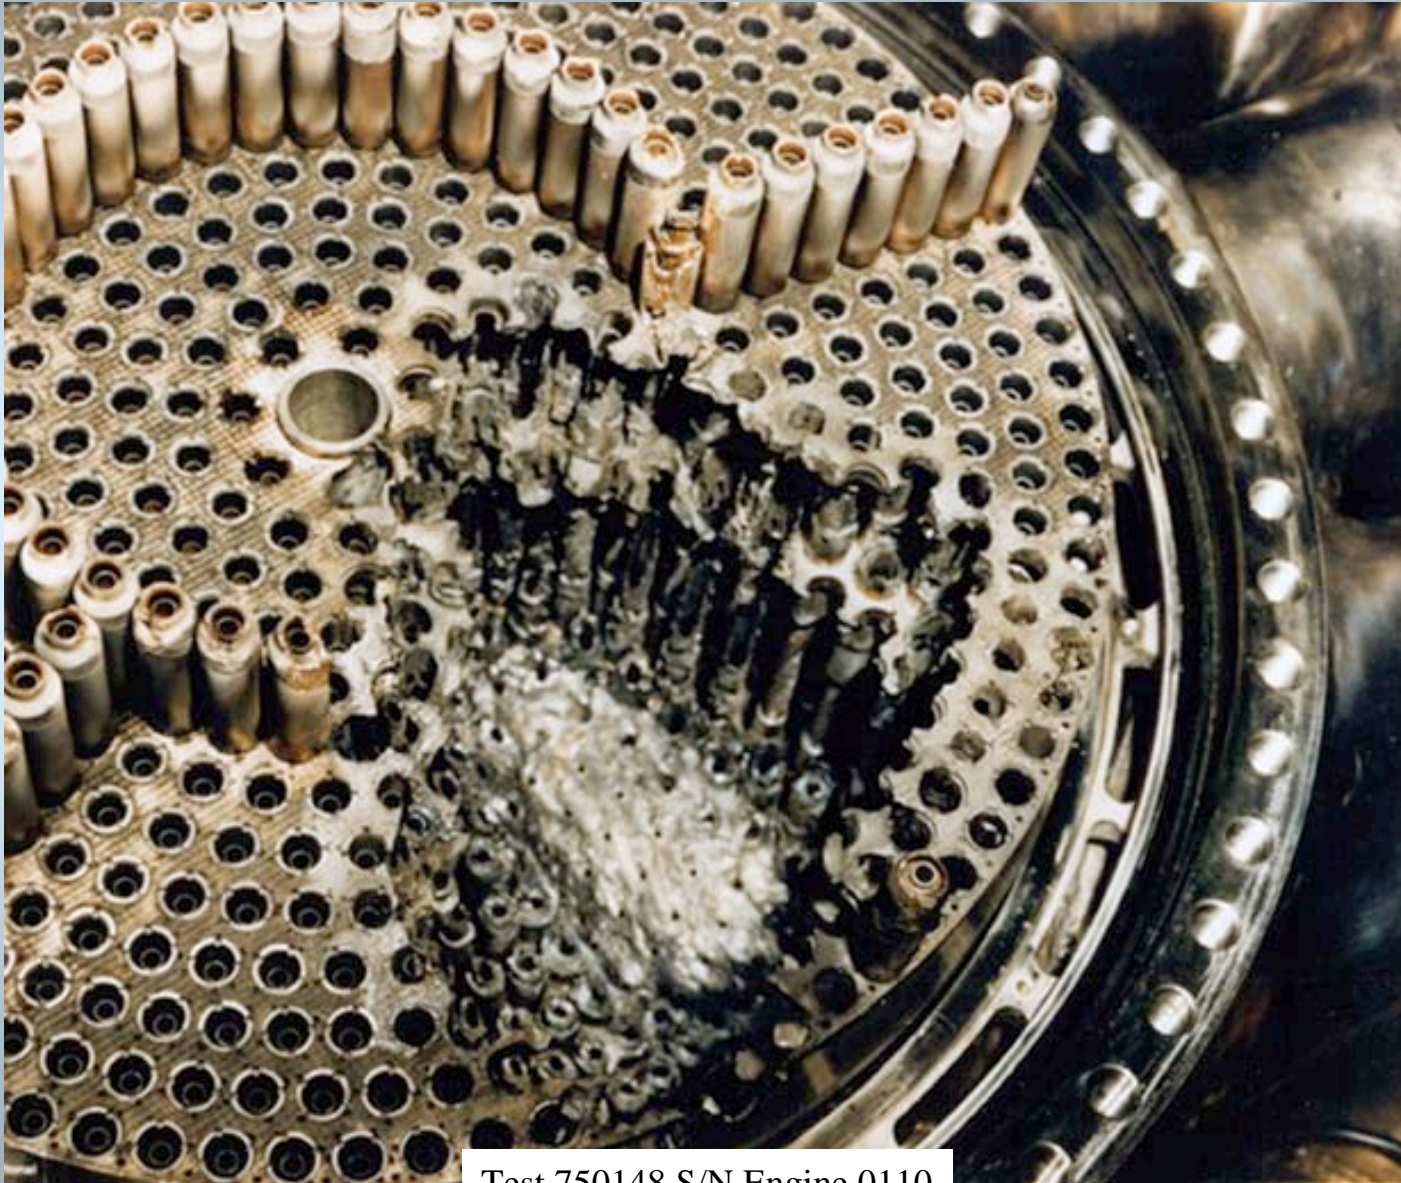
Test 750148 S/N Engine 0110

Inspection of the engine revealed extensive damage of the fuel preburner side of the main injector with burn-through of 149 Lox posts, erosion of the primary and secondary face plates, and erosion of the interpropellant plate. The nozzle sustained shrapnel damage to approximately 150 tubes and the MCC suffered erosion damage.

Cause: High cycle fatigue of Lox post caused by random mechanical vibration of the powerhead and flow induced vibration from the hot gas combined with high steady-state stresses. The damage pattern of the injector indicates the failure occurred at the inertia weld of post 12, row 13. However, the posts in this vicinity were largely consumed by the fire, including the fatigue crack where the failure initiated. Post 12, row 12, which is very near the indicated failure location, had been reworked and the acceptance requirements relaxed, making this post a credible candidate as the failure initiation point. 5. All evidence points to high cycle fatigue near a Lox post inertial weld as being the single cause.

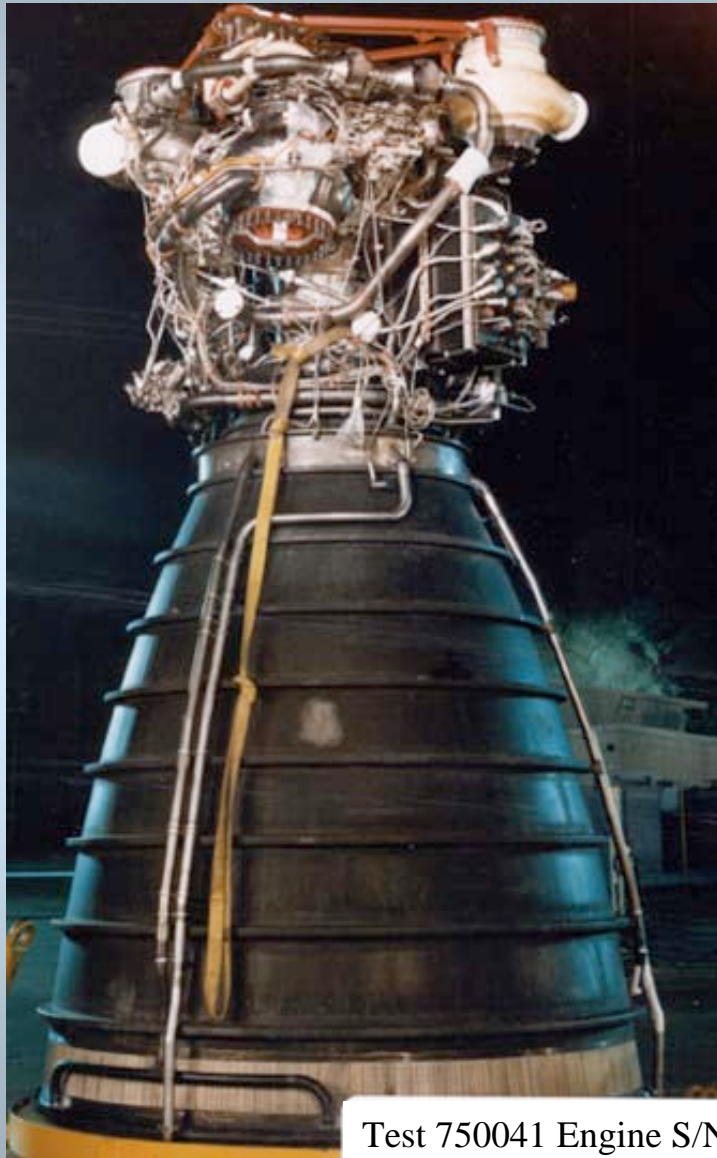
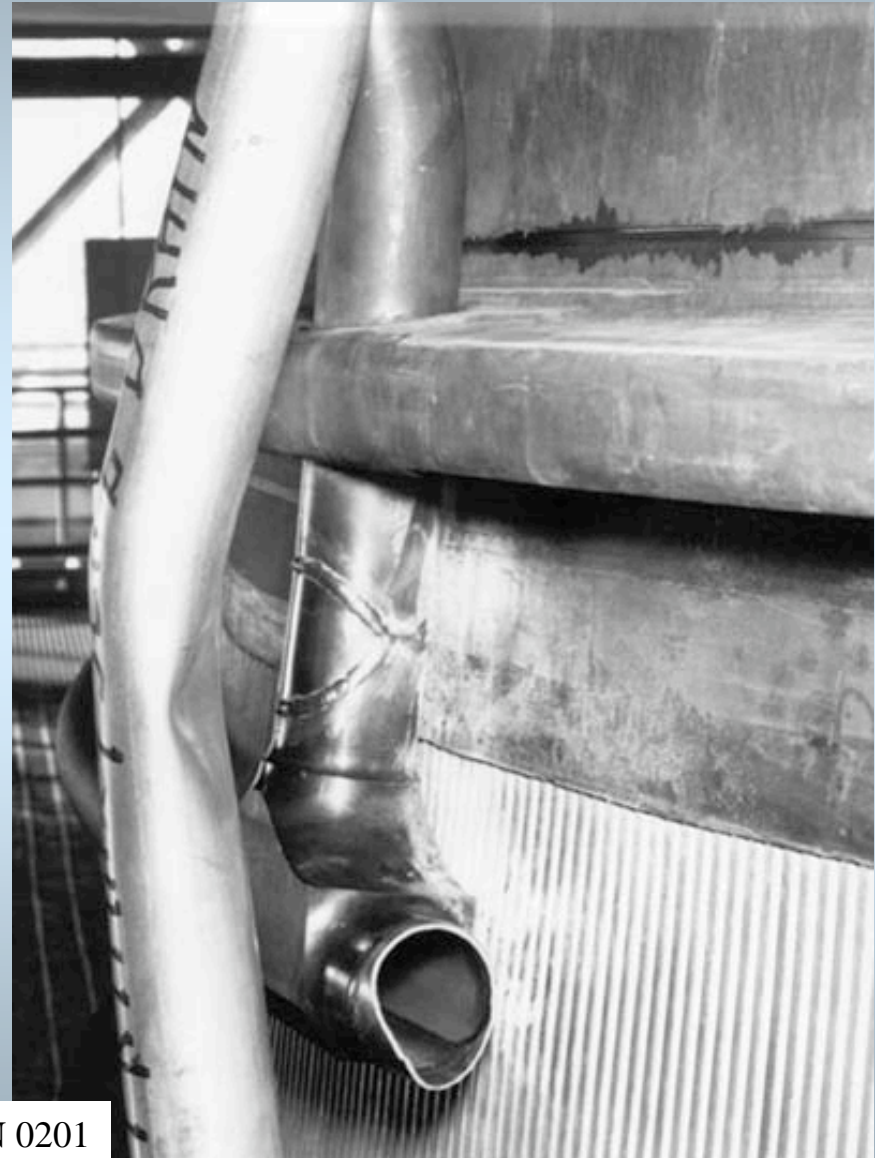
Test 750041 Engine S/N 0201

Incident Description: Test 750041 was automatically terminated at 4.296 seconds when the HPFTP turbine discharge temperature exceeded the redline value. The engine sustained considerable damage internally due to the loss of hydrogen flow during shutdown. Review of the motion picture film and data evaluation indicates that there were actually two incidents in this test. The first incident was the hot start which resulted in an high initial temperature spike in the high pressure fuel turbopump turbine discharge temperature. When the engine reached steady state the temperature again exceeded the redline value and shutdown was initiated. The second incident was the failure of the hydrogen feed line (steerhorn) to the nozzle. This occurred as the engine preceded through shutdown. This caused loss of hydrogen to the engine and the resulting damage. Damaged hardware included extensive overheating and erosion of both HPFTP and HPOTP turbines, extensive overheating and massive tube ruptures in the nozzle, extensive erosion of the main injector (not repairable), extensive slag deposited on the MCC, erosion of the fuel preburner liner and body, and extensive erosion of the hot gas manifold liner (fuel side).

Cause: A small crack was found in the failed steerhorn which was the initiation point of the failure. Metallurgical analysis of the failed area indicated that all of the damage may have been accumulated in this one test. Engineering analysis of this test however, could not identify any loads high enough to fail the steerhorn in this one test. It was postulated that the steerhorn could have accumulated damage from previous testing without cracking. Strain gages were place on engines being hot fired and previously unidentified 200-400 Hz oscillations were found during the start and shutdown transients. The loads from these oscillations had not been included in the design of the steerhorn. Utilizing data obtained with strain gages from eleven tests gives a projected life of 44 tests for minimum fatigue properties. The nozzle from engine 0201 had accumulated 12,109 seconds of test time during 48 tests.

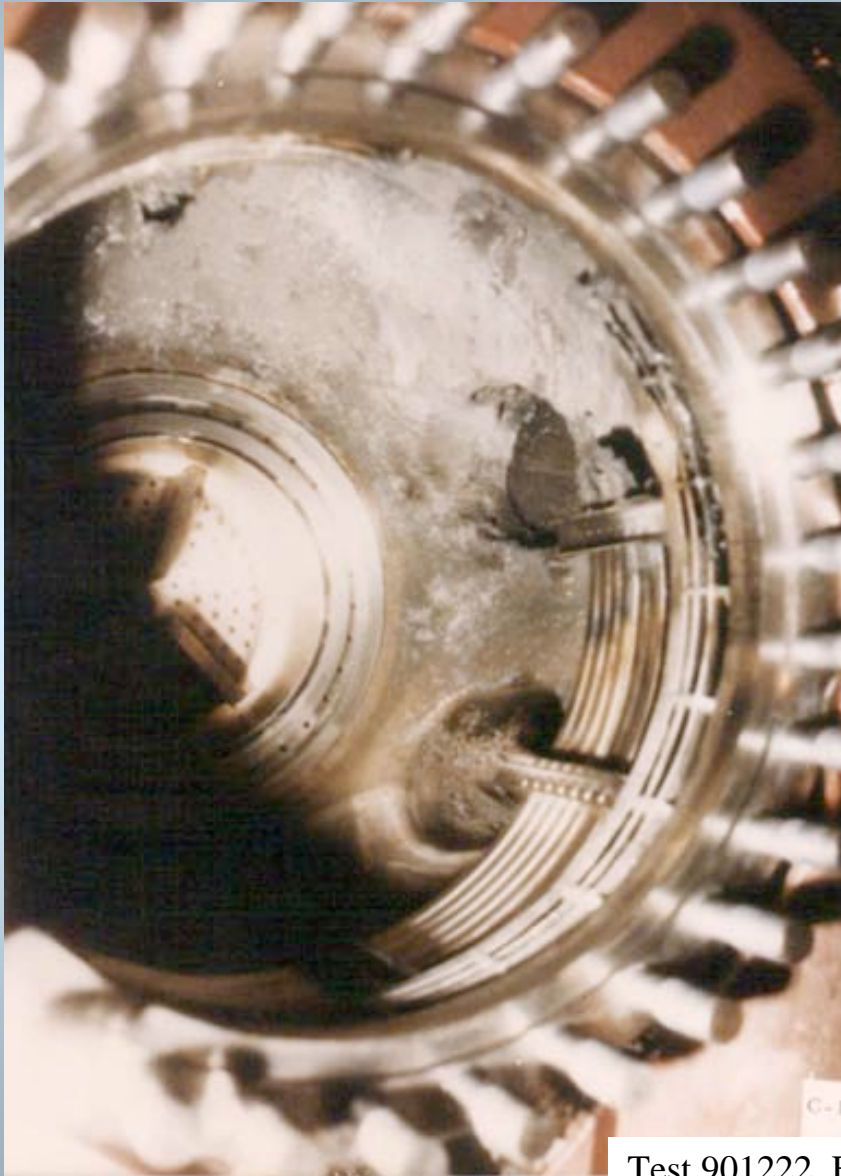
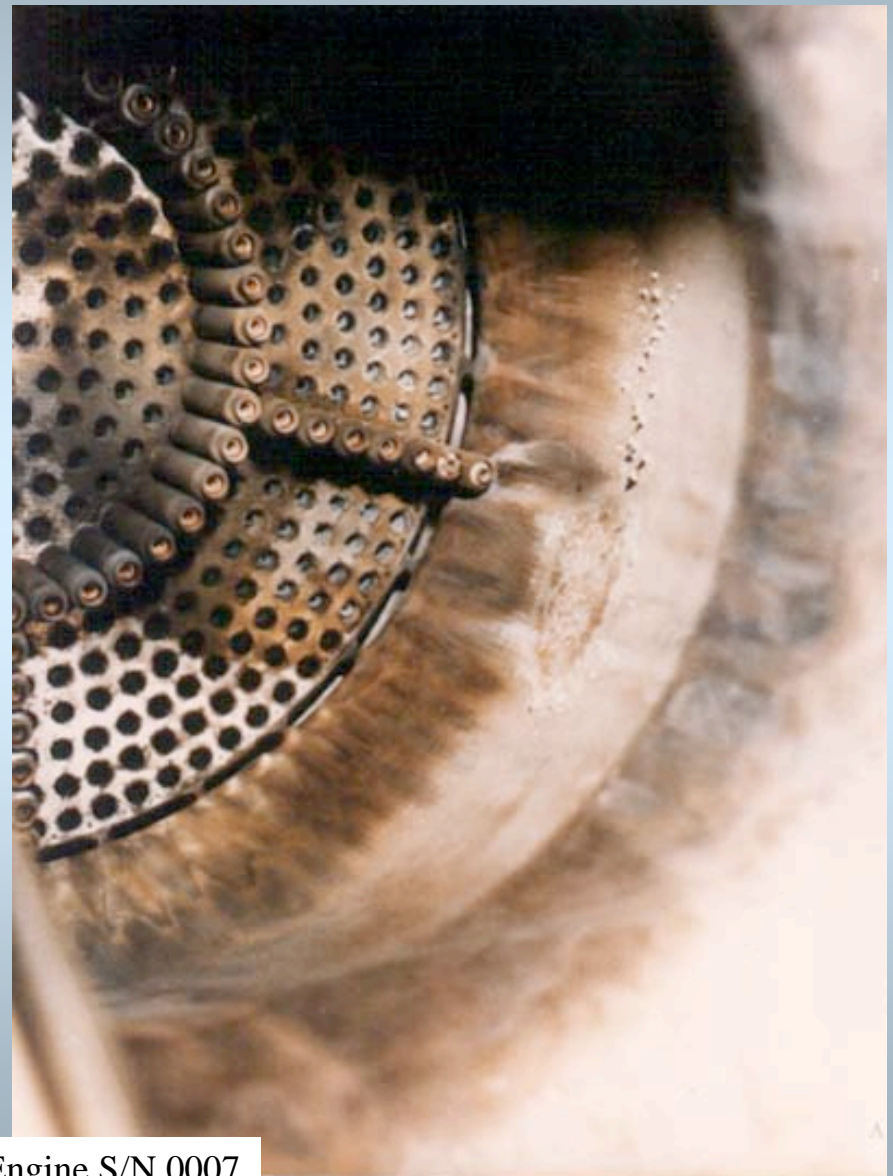
Test 901222, Engine S/N 0007

Incident Description: Test 901222 was terminated at 4.34 seconds by the heat exchanger outlet pressure minimum redline. Simultaneously, external fire was observed in the area of the oxidizer preburner. Extensive occurred to the heat exchanger coil, oxidizer turbine discharge area gas manifold, main injector and heat exchanger discharge line.

Cause: It was concluded that the incident could have been caused by one of two possible failure modes. One possible cause is undetected damage to the inlet tube during failure modes. One possible cause is undetected damage to the inlet tube during manufacturing. Following welding of the inlet, the small diameter inlet passage is reamed to remove weld drop-through. If the reaming operation penetrates past the planned depth or is performed off center, extensive damage may occur to the internal surface of the coil. The key supporting rationale for this failure mode is evidence of reaming penetration. Another possible cause is associated with a heat exchanger bracket welding operation. The No. 1 bracket was weld-repaired near the outlet, in the general area where the failure apparently originated. The exchanger bracket welding operation was conducted after the final proof pressure test. The grounding method -- to the bowl rather than directly to the bracket -- may have caused high frequency current arcing between bracket and tubing, damaging the tubing.
